# Manhole Inspection Summary

Manhole # S29AA1009MH

**Location** Address: **3523 CHESTNUT AVE**

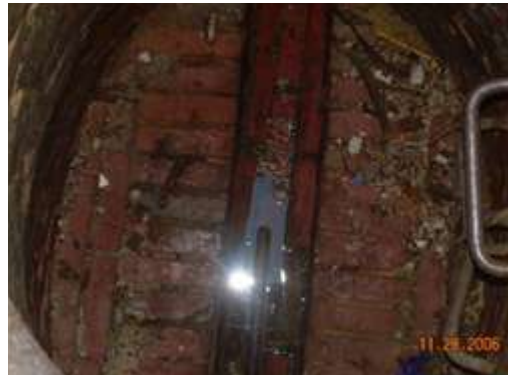
Top View

Bench and Channel debris.

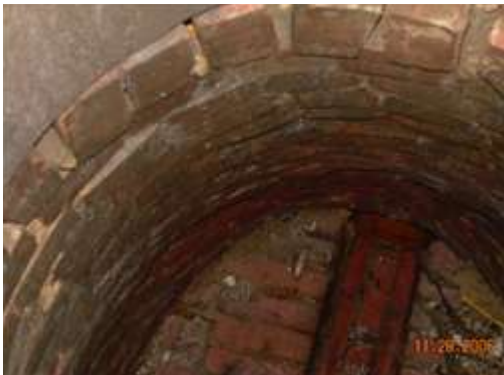
Defect

☒ **Leaks**

Condition: ☐ Sound ☐ Cracked ☐ Root Intrusion ☒ **Loose Brick** ☒ **Deteriorated**

Infiltration: ☐ None ☒ **Joint** ☐ Cracks ☐ Mortar ☐ Roots ☒ **Wall**

Infiltration: ☐ None ☐ Joint ☐ Cracks ☒ **Mortar** ☐ Roots ☒ **Wall**

Frame leaks. Adjustment deterioration, loose brick and infiltration. Corbel infiltration.

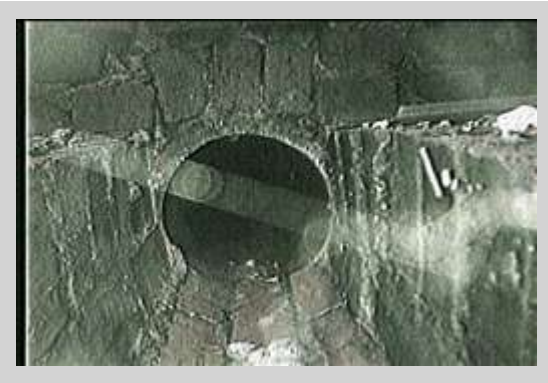
Pipe Out @ 12 O'Clock

Barrel deterioration and infiltration. Channel deterioration.

Infiltration: **Evidence** Pipe Seal Cond: **Cracked**

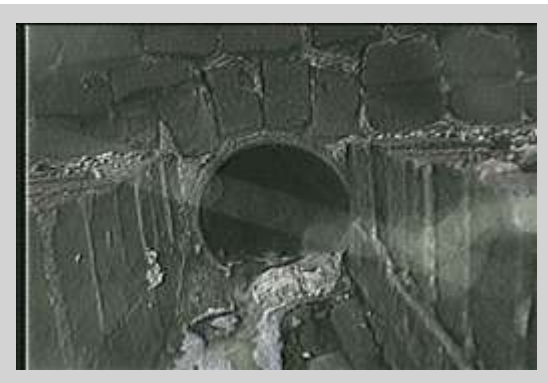
Pipe In @ 6 O'Clock

Barrel deterioration and infiltration. Channel deterioration.

Infiltration: **Evidence** Pipe Seal Cond: **Unknown**
